# Boxster Lift Rod End Replacement Instructions

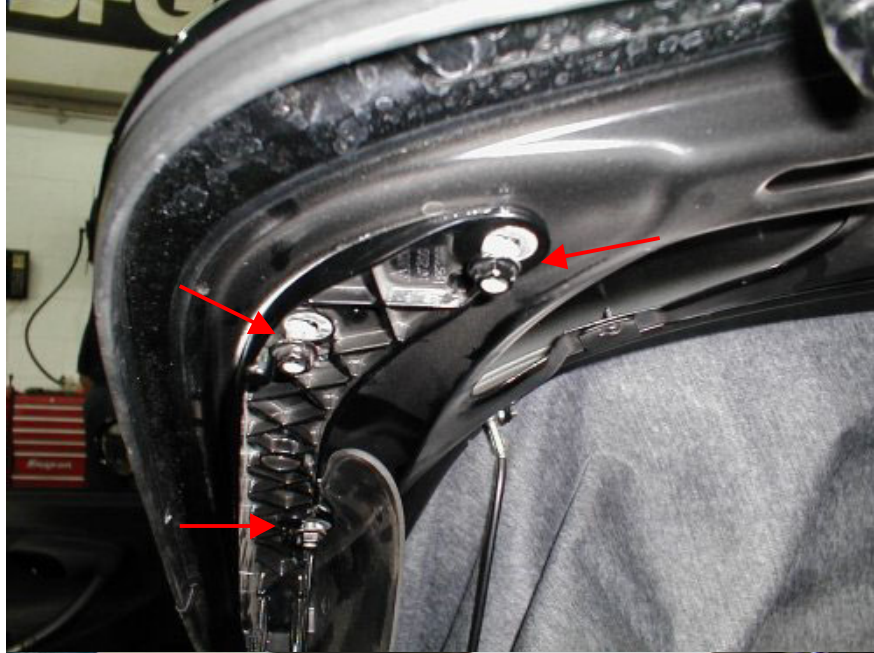
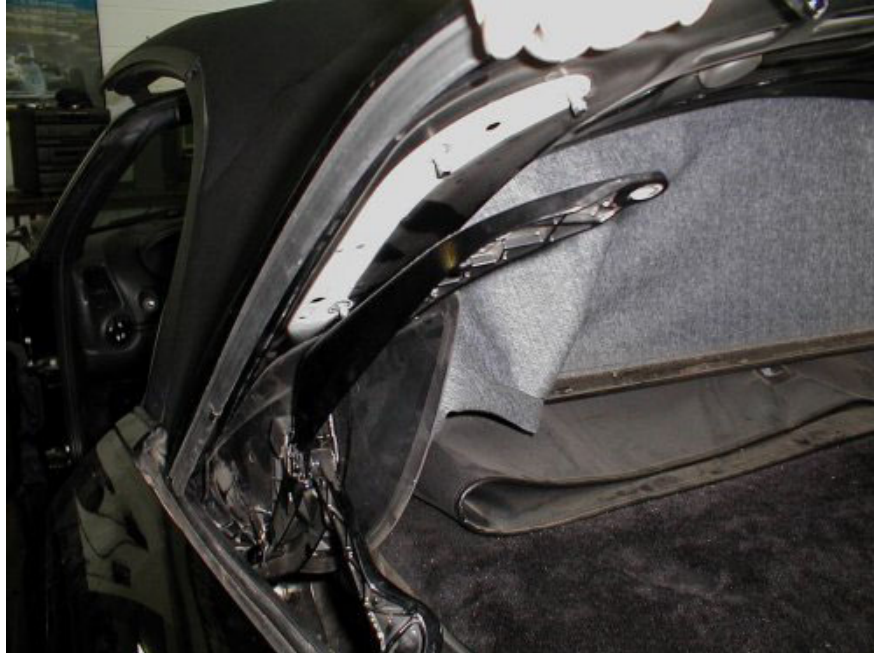
Note the “unpainted” area under the nut. This will help you align the tonneau cover when putting it back on the arms.

- 1) Raise the tonneau cover to an upright position. This will be just before the top starts to pull back.
- 2) Loosen the 6 nuts (3 per side) holding the tonneau cover to the lift arms. Remove the tonneau cover and set it aside.

12) Reinstall the tonneau cover getting the nuts as close to the unpainted area as possible.

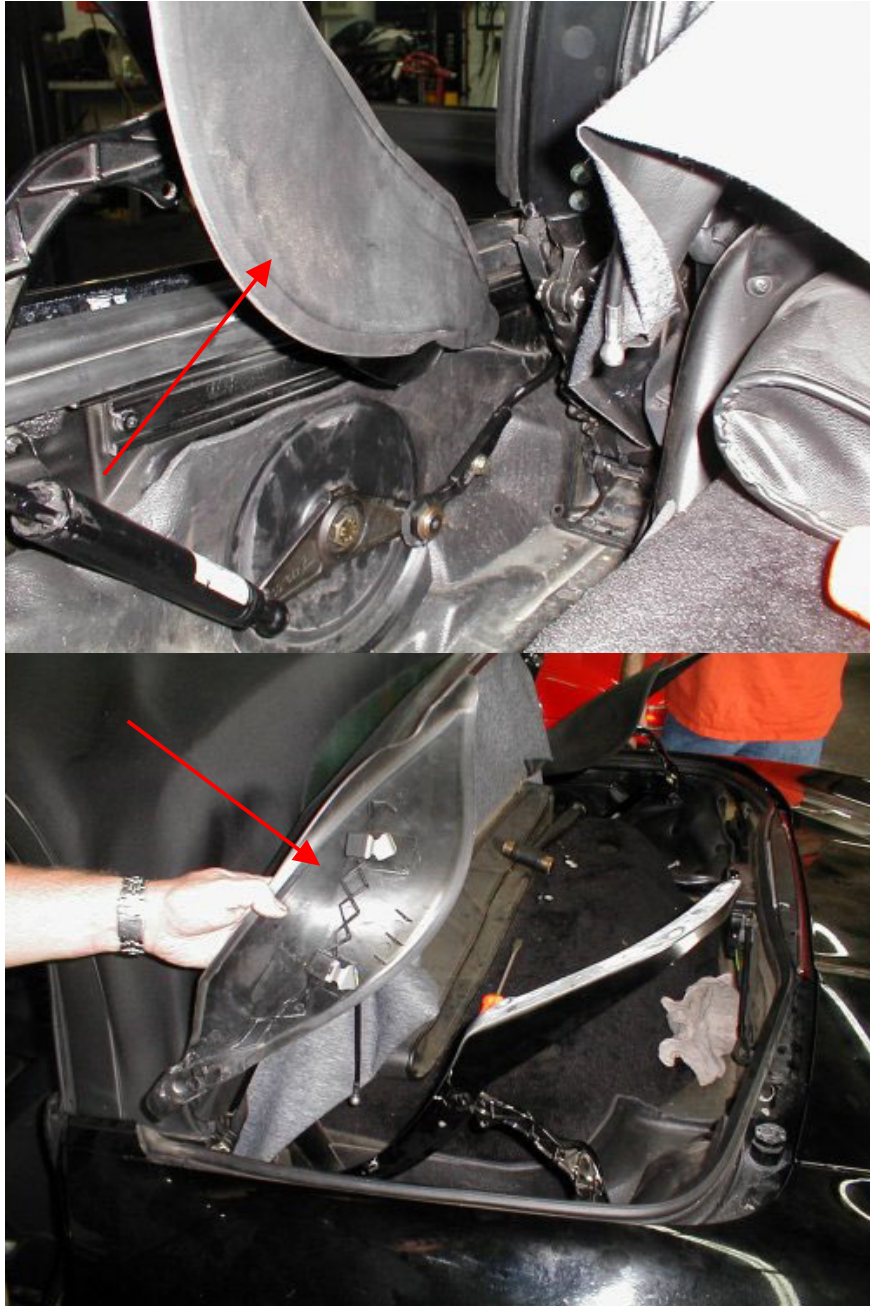
3) Remove the lift arm cover from each side and set aside.

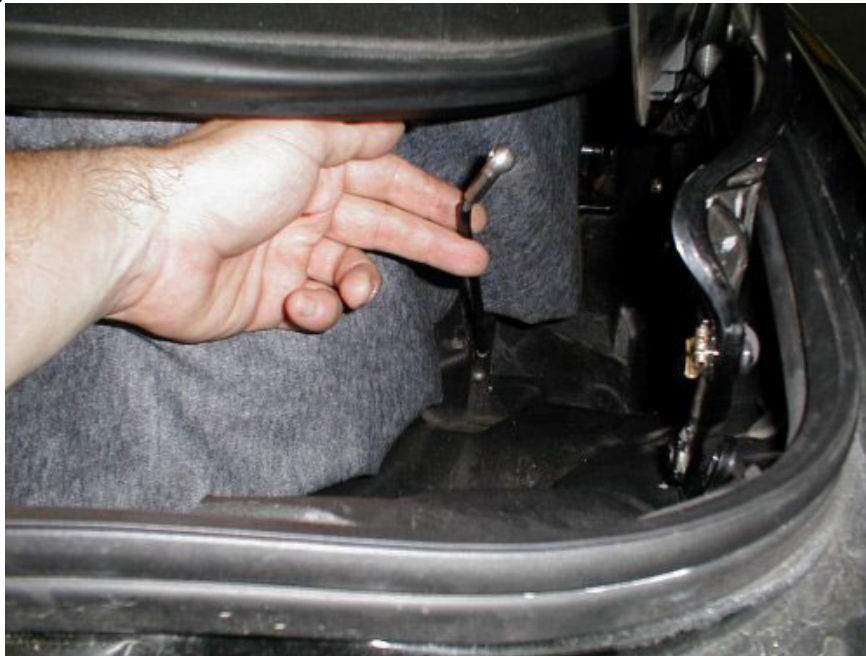
4) Remove one end of the small black cable on each side of the top. I recommend removing the bottom. Pry off with a flatblade screwdriver.

11) Once the assembly is back together. You can test it without the tonneau cover in place. Just remove all tools from the work area. Set the skirt back in place and reconnect the black cable to the top(step 4). Both arms should move freely and in time with each other.

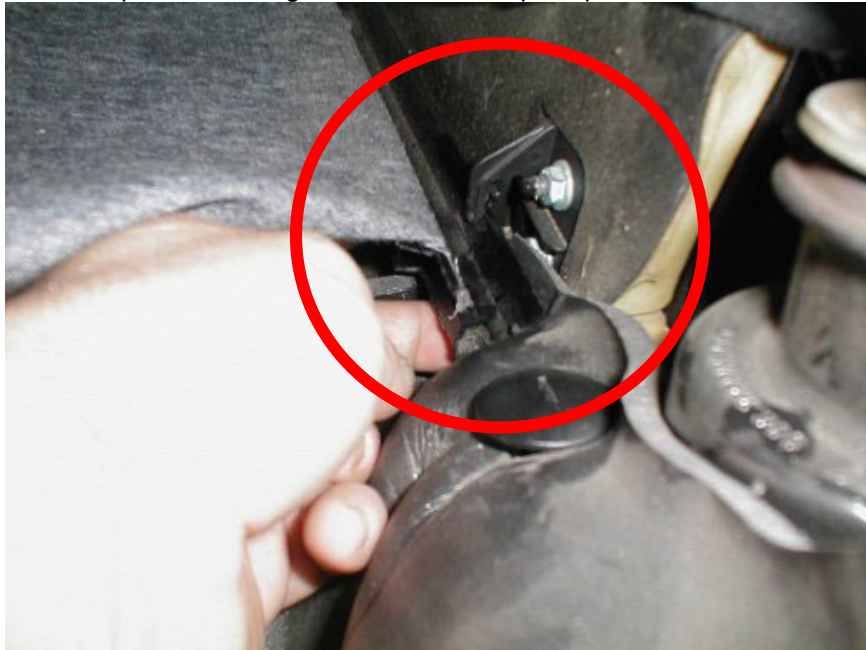
5) The top has a "skirt" that attaches to the back of the car. This needs to be loosened. It basically just has a clip that the bar goes under and snaps in place. One on each side of the car.

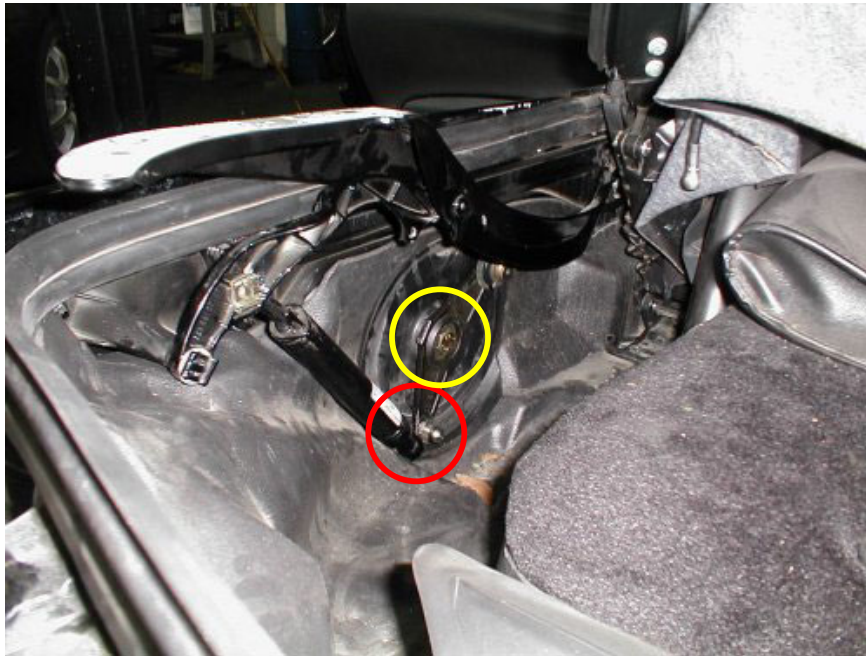
6) You should now be able to see the lift arm assembly. There are 3 steps to removing this assembly. First, pry off the ball end of the black cylinder(red circle). The tonneau cover lift arm should move freely now. Next, remove the 19mm bolt from the transmission assembly(yellow circle)

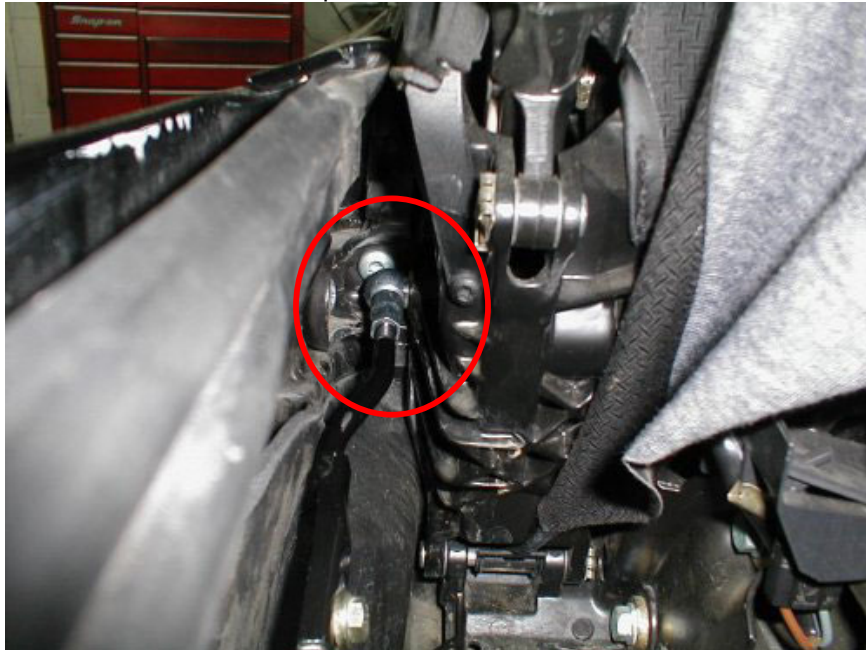
Lastly, pry off the red ball end at the end of the lift arm. Note this one is already replaced with the metal substitute. Yours will be red plastic.

9) Snap the new metal end back onto it's ball on the top and reinstall the 19mm bolt. Before snapping on the black cylinder, test operation of the lift arm. If the lift arm does not sit all the way down and is hitting the lift rod, the rod is too long. Loosen the adjustment bolt I showed you in step 7. Adjust until the lift arm sits in it's closed position and retighten the adjustment bolt.

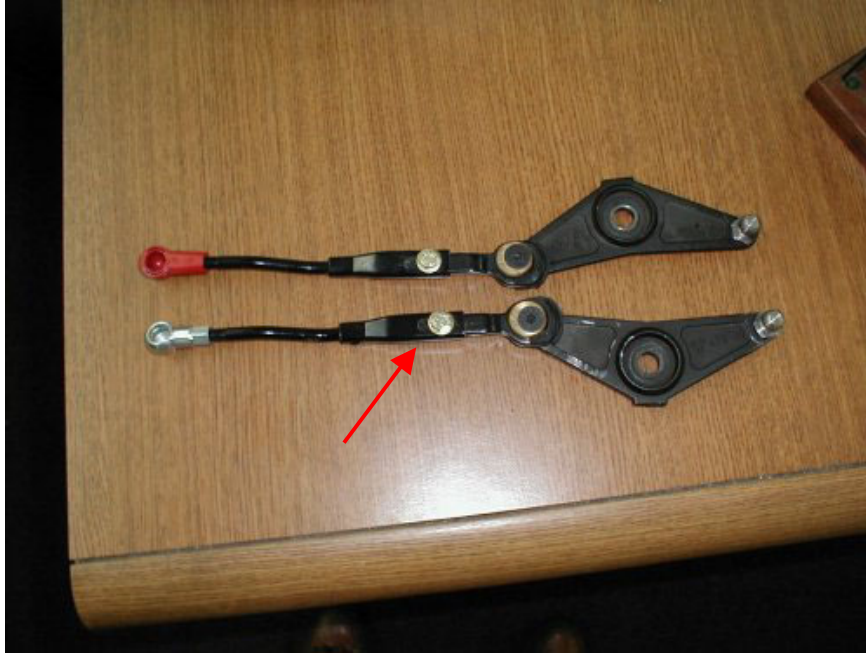
7) The lift rod should be off the car now and in your hands. Unscrew the red end and replace with the metal end.

Note this bolt (red arrow). This is the length adjustment for the entire assembly. You may need to adjust this later when reinstalling. Also, as you can tell from the picture above, there is a left and right to these arms.

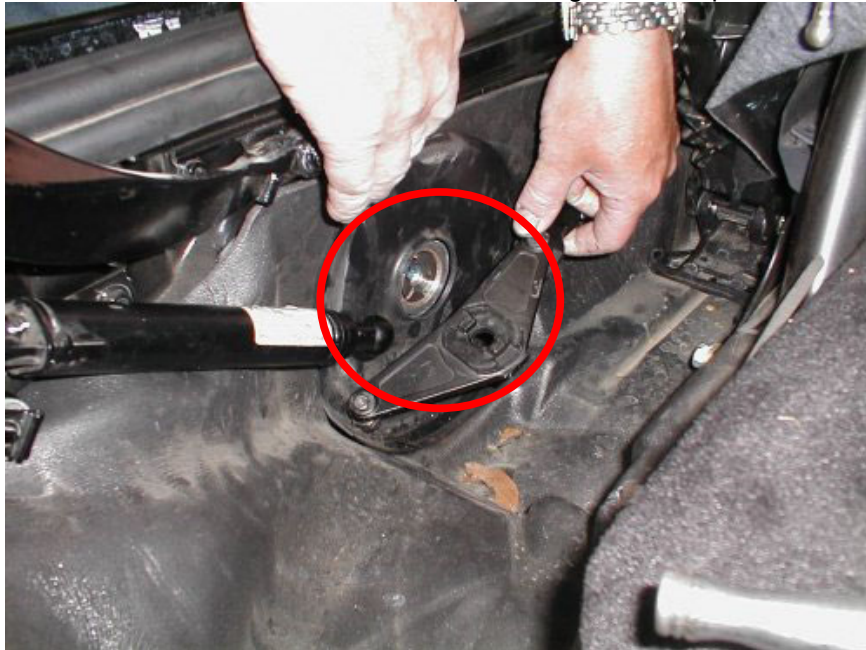
Note on the transmission there is a slot. The tabs in the arm go into this slot.

8) Reinstallation is the reverse of removal. A couple of things I want to point out.

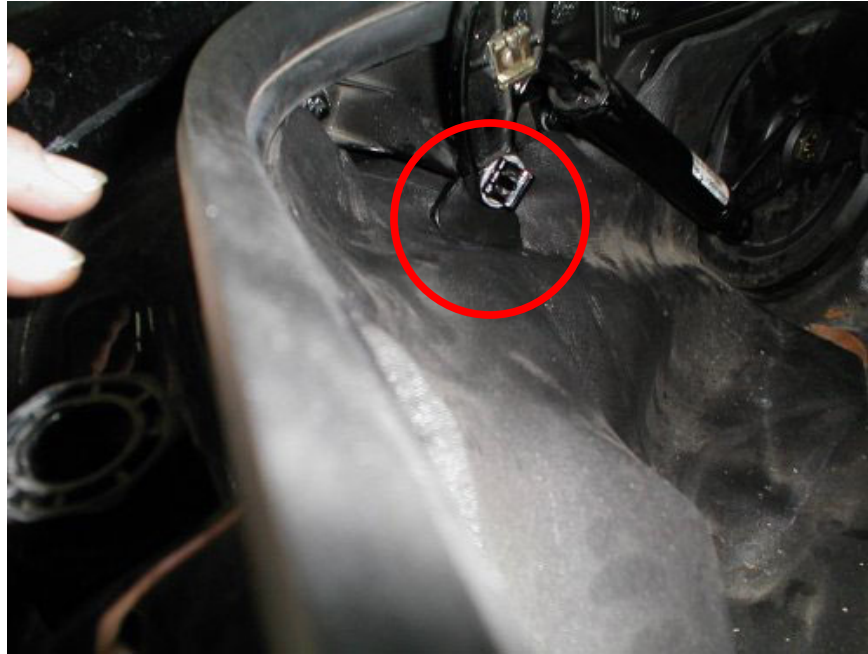
10) There is a black plastic hinge plate that may come loose during this process. Here's where it goes.

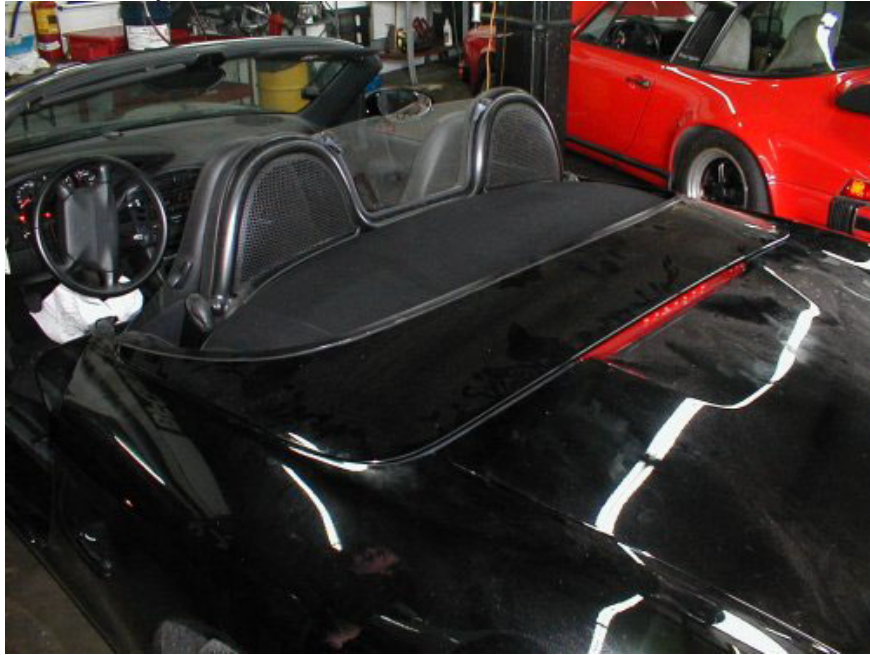
13) Run a final test and your finished.
